Severe and acute hypercapnia, subsequent to the mistaken connection of a carbon dioxide cylinder on the nitrous oxide manifold: a report of three simultaneous cases

S. CHAKUPURAKAL¹, G. GAMELA², Y. GHOSEZ², P. VAN DER LINDEN³

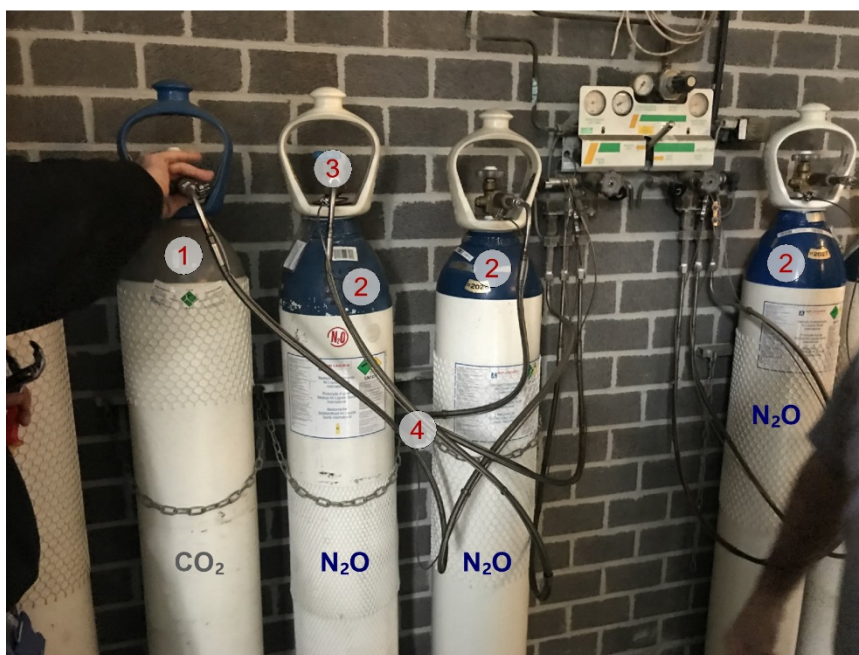
A technician was sent to check the gas delivery system in the basement who was able to identify a CO₂ cylinder mistakenly connected on the N₂O manifold (Figure 1). The CO₂ cylinder appeared to have the same fitting as the N₂O cylinder.

Fig. 1 — CO₂ cylinder (grey shoulder) mistakenly connected to the N₂O manifold (N₂O cylinders with blue shoulders). Photo taken by the technician during his checkup of the gas delivery system. 1: CO₂ cylinder, 2: N₂O cylinders, 3: connection of the fitting on the thread, 4: connecting lines.

In our case, all these possibilities have been ruled out. The mistaken connection of the CO_2 cylinder on the N_2O manifold could occur because these cylinders had the same fittings.

verify them. In the gas storage and distribution room, the cylinders are connected on the manifold via a connecting line ending in a fitting. The fitting is connected to the thread of the cylinder. The manifold is then connected to the hospital network (Figure 1). These cylinders have the same volume (50 liters) and pressure (50 bars). The colors of the gas cylinder shoulder (grey for CO_2 and blue for N_2O) comply with the European standard EN 1089-3⁷. However, with regard to cylinder fittings, each country in Europe has its own national standard for cylinder fittings and there is no standardized European standard for cylinder fittings. It should be noted that in Belgium, standard NBN 226 applies⁸. This standard dates from 1950 and has never been revised.

Measurements taken at fittings B4 and B5 indicated that there is a difference of 0.2 millimeters in the internal diameter between these two fittings; 19.3 mm versus 19.5 mm respectively. Measurements taken at the thread of N_2O and CO_2 cylinders for a B4 fitting show that they have the same diameter and length.

It is therefore possible to connect a N_2O cylinder or a CO_2 cylinder via a B4 or a B5 connection on the manifold without forcing. This erroneous maneuver was tested in our center and showed high reproducibility. Thus, even if the two possible fittings are used for the different gasses within a facility, they are so similar that a mistaken connection is still possible.

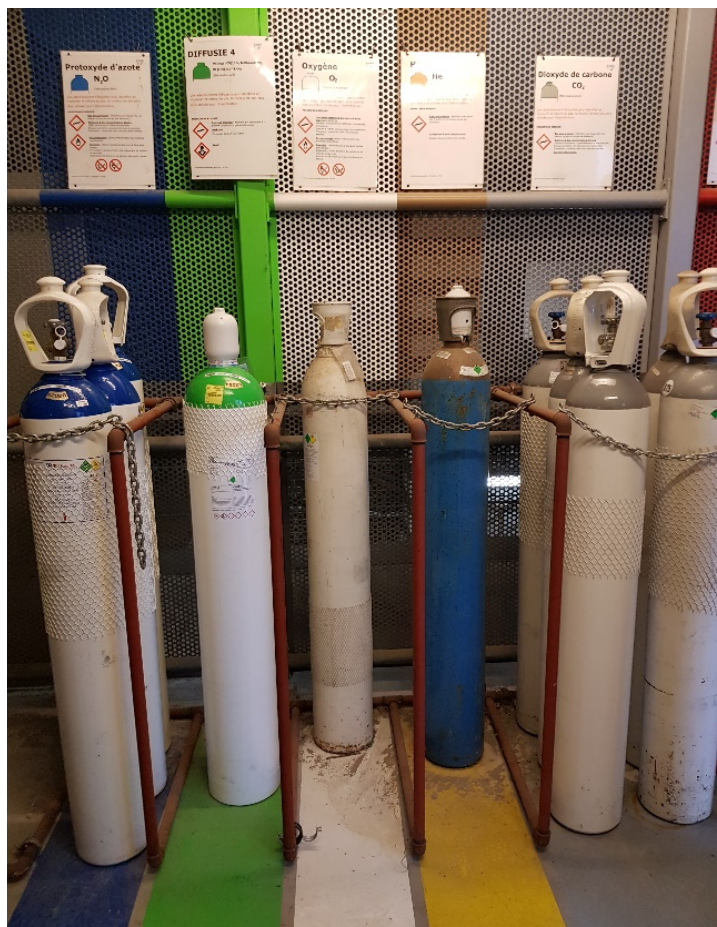
Fig. 2 — A visible identification of the cylinders via clear labeling on the wall and via a color-coded marking on the ground.

- A specific training for the hospital technicians has been designed, informing on the dangers and specificities of each cylinder.
- A more visible identification, including a label on the wall and a matching color-coded marking on the ground (Figure 2).
- The process of changing cylinders now requires a double-check with the supervision of the hospital pharmacist.
